Konstruerad av JA	Granskad av SE	Godkänd av - datum JA - 2017-01-27	Generell tolerans SS-ISO 2768-1	Generell Ytjämnhet, Ra	Vyplacering 	Skala 1:8
Ägare 		Titel/Benämning Ten, Pålboj/Long Mooring Buoy		Utgåva A	Blad 1(1)	
		Ritningsnummer 62223

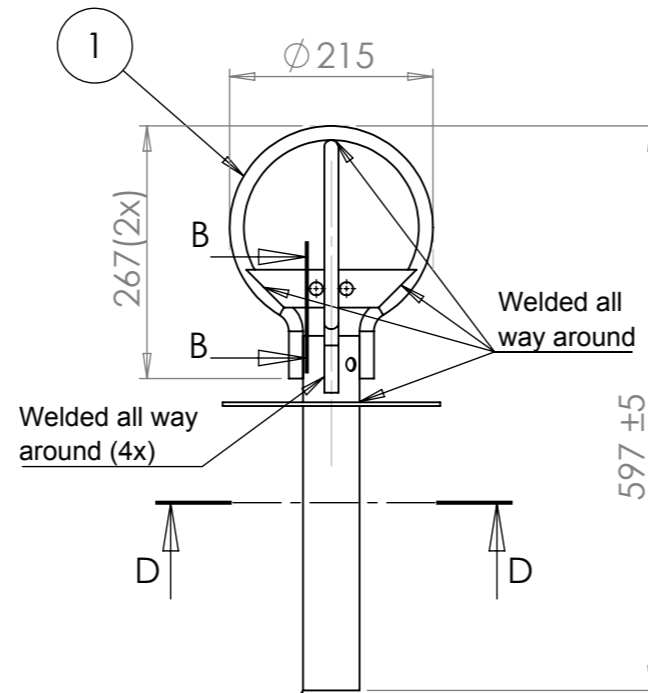
Rörets båda innerändar noggrant gradade!
Sharp edges in the pipes both ends carefully removed!

1. Stång/Rod: $\varnothing 15$, EN 10025 Fe 360 B
2. Platta/Plate: $t=5$, SJ 235
3. Rör/Pipe: $\varnothing 60 \times 2$, EN 10210-1
4. Platta/Plate: $t=4$, SJ 235
